**I – OVERVIEW**

**II. – PAN AM RAILWAY OWNED SEGMENT IN MAINE**

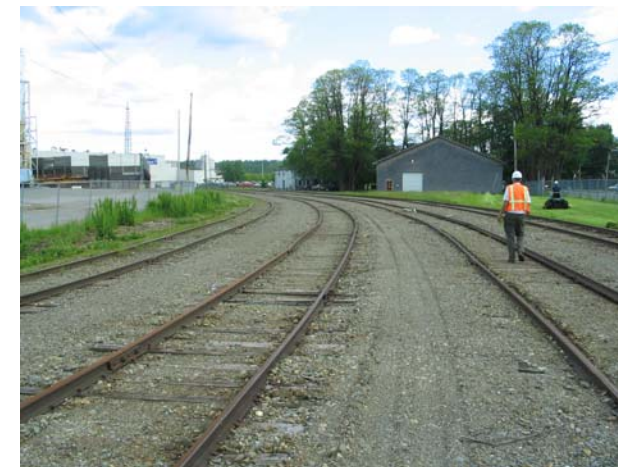
Figure 5-2 Woodland Yard, Middle Section

The rail is generally 85# ASCE, in serviceable condition. Track surface and alignment were generally good. The track is reasonably well drained. Rail anchors were virtually nonexistent. The turnouts were in fair condition and needed only normal maintenance and switch timber replacement with the exception of the north end, where self guarded frogs have moved southward due to a general lack of rail anchors. These frogs need to be re-secured to the timbers.

1. An average of 15% of switch timber in the seven No.8 turnouts should be replaced. This would amount to 520 LF total of replacement timber.
2. Derailment damage should be repaired on Track 7. Approximately 230 feet of rail is rolled out on curve. Track should be re-gauged and replace 25% of crossties.
3. Correct track gage (4' - 10 1/4") in median between lanes, crossing to mill chip unloading, Track No. 7.
4. Replace approx. 20% of crossties (855 replacement crossties)
5. Install rail anchors on all tracks (3,375 total)

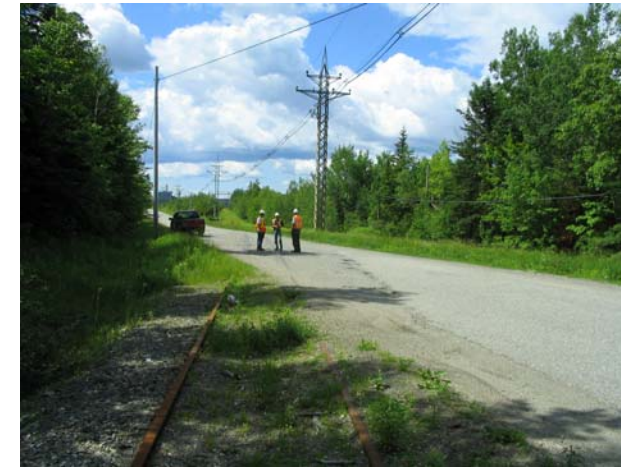
Figure 5-4 Private Crossing on Spur to LP Mill in Woodland with High Skew Angle

There are two grade crossings on this track segment. One has a very flat skew or crossing angle (Figure 5-4). It is assumed that new crossings surfaces and track would be constructed through these crossings.

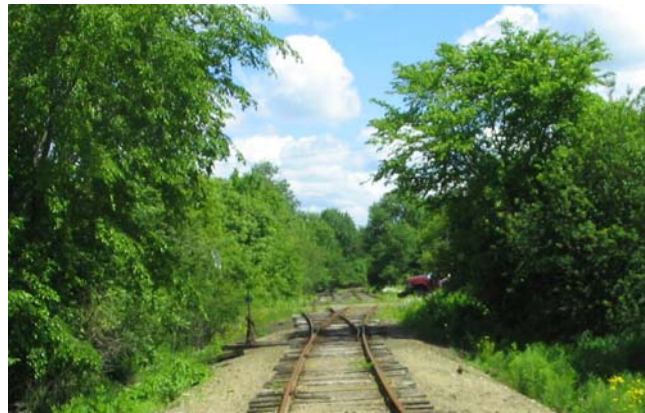
Figure 5-6 Turnout, Siding and Reverse Curve at Baring.

At Baring (Figure 5-6), the No. 8 turnout should be retired, along with the stub track (200 feet of 60 lb rail) and the main track realigned to eliminate the unnecessary reverse curve that occurs here due to the siding and turnout placement.

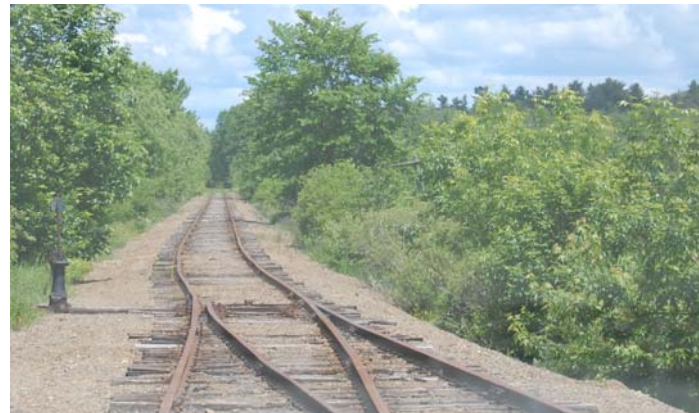
Figure 5-7 St. Croix Junction, Looking Towards Calais. Note Reverse curve due to Placement of Turnout in Curve to Track to the Right

At St. Croix Junction, the 85# No. 8 turnout should be upgraded to at least 100#. The turnout requires switch timber replacement of 60%, or 415 LF of new switch timber. The alignment at this turnout (see Figure 5-7) perhaps should be corrected. The turnout is located in a curve favoring the line south to Ayer's Junction and Bangor. A reverse curve is created on the line towards Woodland.

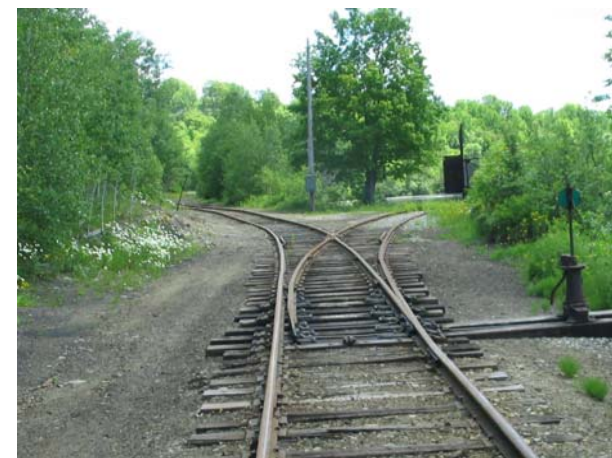
At Milltown Junction in Calais, (Figure 5-10) where the New Brunswick Southern interchange track diverges to cross the St. Croix River, the existing 85# No. 5 turnout for Track 20, the interchange track itself; should be upgraded to a 100# No. 8 if the alignment can be accommodated. A cursory assessment by eye indicates that this more gradual turnout would fit if the turnout were placed further along the Calais Branch toward Calais.

Figure 5-10 No. 5 Frog Turnout at Milltown Jct. Looking South. Salmon Falls Br. 269.02 to NBSR is to the Right.

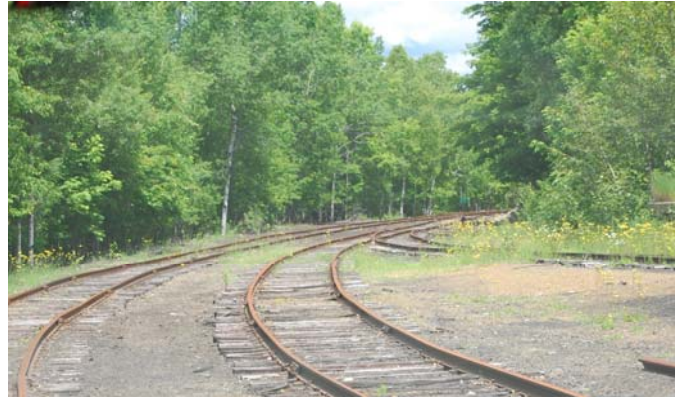
The Track 11 turnout leading to the unused roundhouse can be retired at Milltown. The runaround track (Track 5) could be extended a short distance by relocating the turnout south toward Milltown Junction if more runaround length is needed. Approximately 456 LF of switch timber should be renewed in the turnouts at both ends of track No. 5

Figure 5-11 Track 5 Runaround, Middle Track and Track 11 to Former Round House to Right

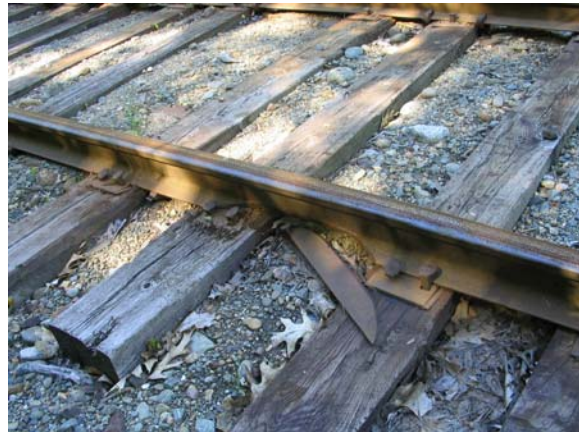
The 4.3 track miles of 75# rail should be replaced out-of-face. This rail exhibits numerous service failures such as broken bases, vertical split head defects and head and web separations.

Figure 5-12 Broken rail base in 75# Rail

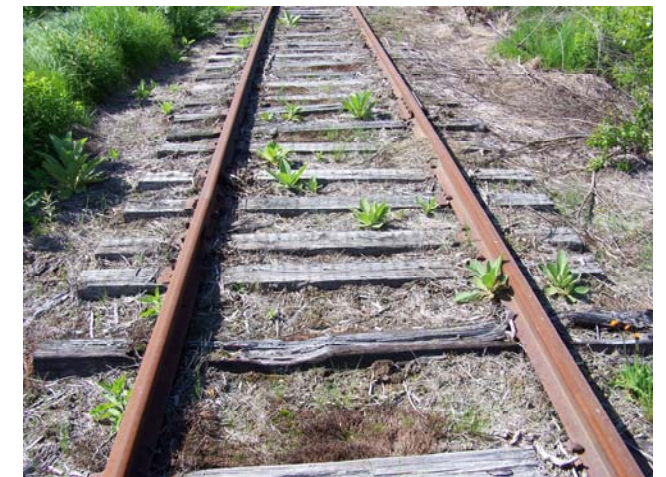
Figure 5-15 Close up of Tie Condition

The condition of crossties varies. There was no sign of any crosstie renewals since about 1975, with the vast majority of crossties dating from the 1930's, 1940's, 1950's and 1960's. Although many of these crossties appear to be sound, experience has found that, when the track is re-ballasted and raised, the older crossties will dry out and break down rapidly. Therefore, the recommendation for crosstie renewals is dense enough to compensate for that and provide adequate rail support and gauge restraint. Consideration should be given to straightening slued crossties.

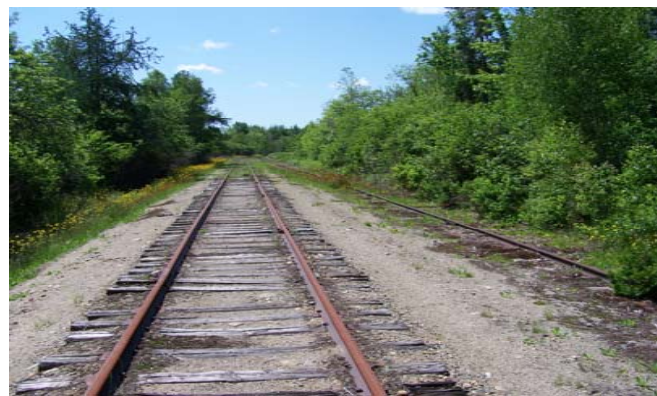
Figure 5-19 Charlotte Siding to the Right

It is recommended that the Charlotte Siding (Figure 5-19) and the turnouts on each end be removed. One frog is missing and the other is unfit for main track use unless it has welding repair of the manganese casting of the RBM frog.

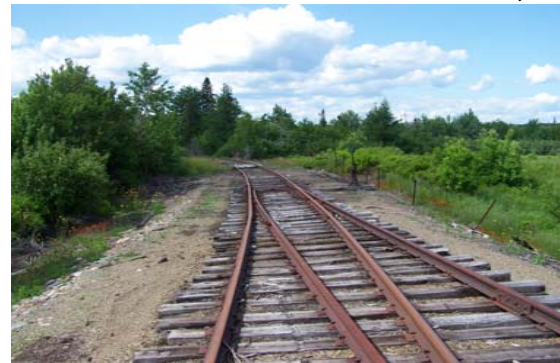
Figure 5-20 East Main Track Switch Ayers Jct.

The east main track switch at Ayers Junction (Figure 5-20) should be removed, along with the remaining main track west of the switch. The No. 8 - 85# turnout could be salvaged for reuse elsewhere. The salvaged Rail could be used elsewhere on the Project.

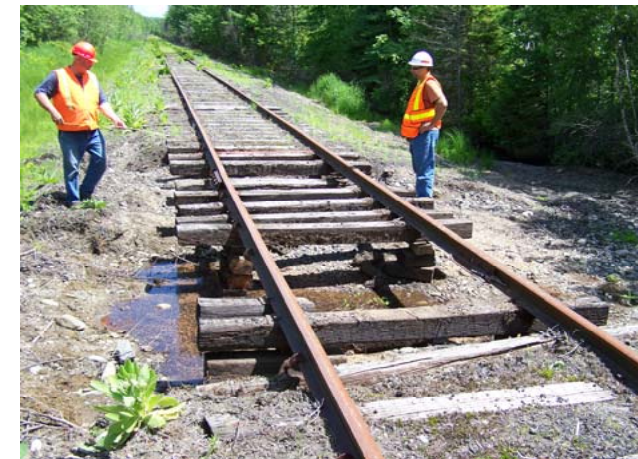
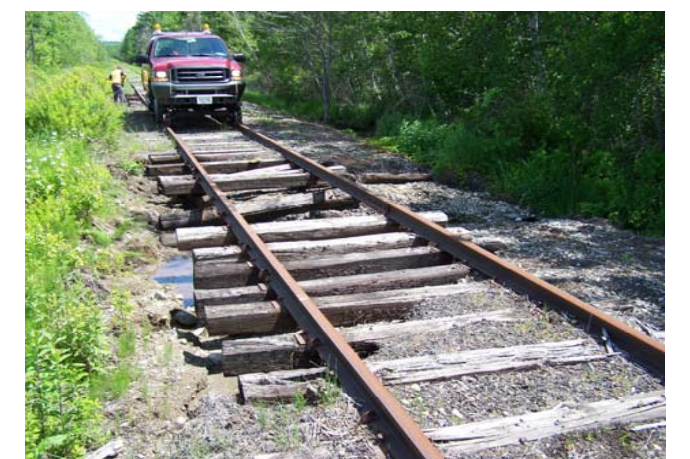
Seven washouts were observed in the vicinity of MP 256.9 to MP 256.65. These appeared to be the result of beaver activity in a culvert and varied from 32 feet long and 16" deep to 15 Feet long and 9" deep. The total length of washed out track was approximately 170 feet.

Figures 5-23 and 5-24 Two of the Washouts between MP 256.6 and 256.9

Some of the culverts could not be found that were on the inventory list and the team would recommend some additional culverts be installed at the washout locations. E.g. MP 256.90 to MP 256.65 near Round Pond.

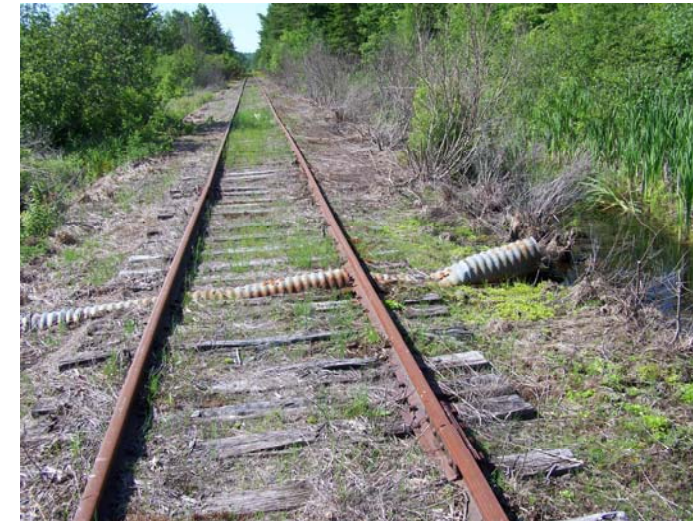
At MP 261.67, this 12" CMP has failed and we recommend this culvert be replaced at a proper elevation to accommodate the water level and also be increased by one size.

Figure 5-25 Crushed CMP Pipe at MP 261.67

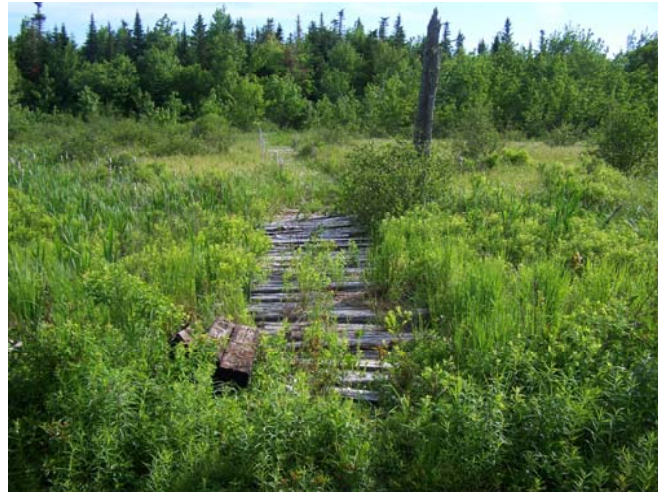
Figure 5-31 Plank and Crosstie Trail Off ROW

At about MP 255.8, a plank and crosstie trail, about 4 feet wide, departs east from the roadbed (Figure 5-31). This trail may allow snowmobiles to operate across the bog.

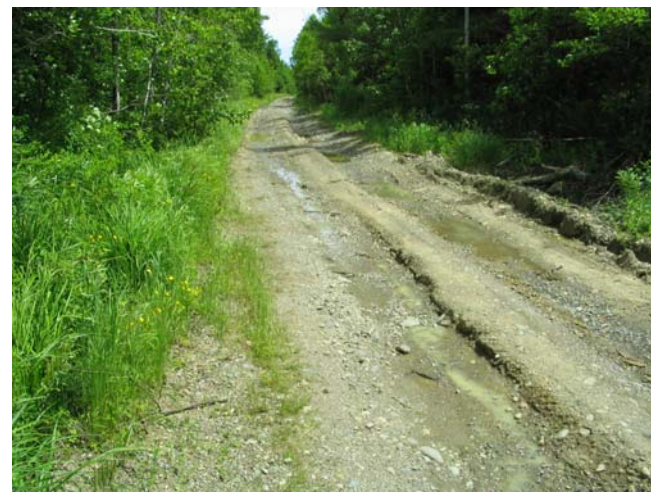
Figure 5-32 Rutting due to Logging Operations

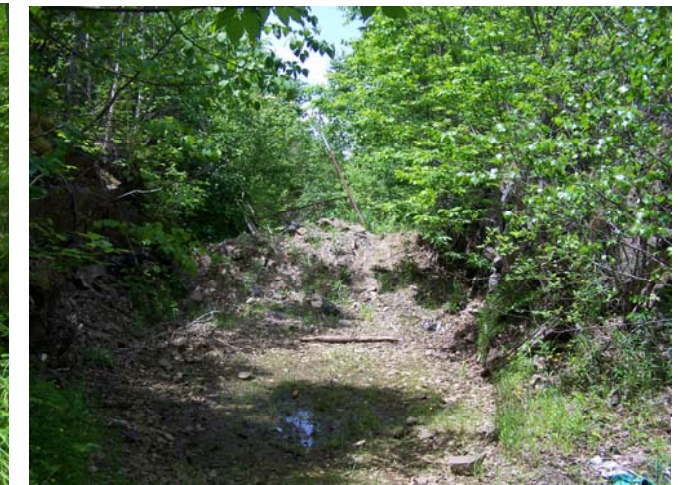
At about MP 260.5, a seven foot high barrier of earth and debris has been pushed up, (Figure 5-34) apparently with a dozer, in a rock cut. This was obviously intended to block motor vehicle access. ATV's are detouring around the barrier and continuing to use the roadbed. Trash had been dumped on the roadbed north of the barrier at some time in the past.

Figure 5-34 Debris Pile in Rock Cut

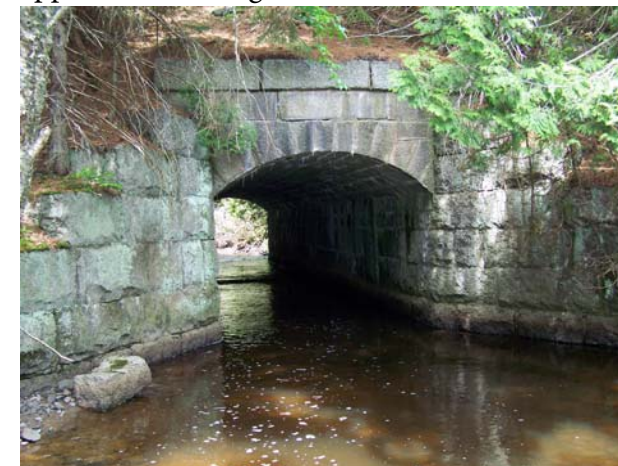
At MP 261.64, a stone arch culvert carries the Little River under the ROW. The arch spans about 10 feet, appeared to be in good condition and has about 16 – 18 feet of cover (Figure 5-35).

Figure 5-35 Stone Box Culvert

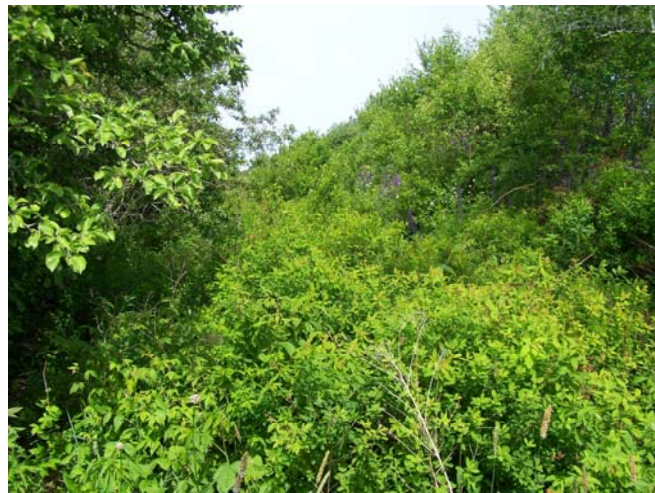
The segment from Golding Road in Perry (MP 262.56) to the Little River Bridge (MP 262.90) and from the Little River Bridge to Perry was densely vegetated with alders, raspberry vines and other plants. Walking was difficult and sometimes it was difficult to follow the roadbed.

Figure 5-36 Dense Vegetation in Perry

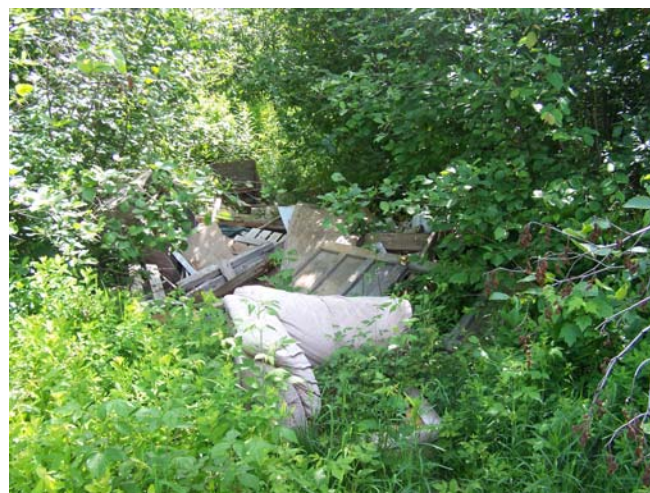
Figure 5-37 Trash Dumped on ROW

Trash has been dumped on the ROW in several places.
