**I. – INTRODUCTION**

**II. – BRIDGE INSPECTION FINDINGS**

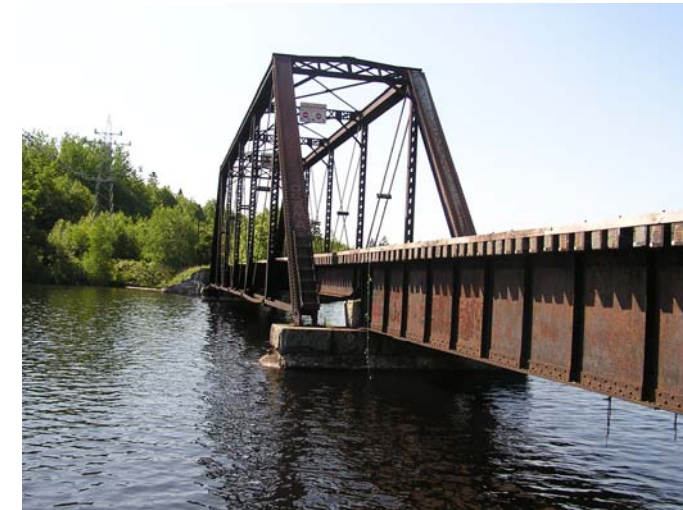
Built c. 1905, this 250-ft long three-span bridge consists of a 150-ft long main span Pratt truss with flanking 50-ft long steel deck girders. The two piers are constructed of concrete foundations topped with granite stones, while concrete abutments and wingwalls support the ends of the bridge. There is substantial scaling and section loss at the concrete abutments and piers (greater than 12-in. deep) below the waterline directly beneath the bearing points of the steel girders. This may be the result of ice abrasion. In addition, abutment wingwalls exhibit severe spalls and cracks throughout. The steel deck girders exhibit shifted bearing plates and missing anchor bolts throughout, while the top flange of one floor beam is slightly rotated. Two longitudinal bottom chords in the truss are bowed. Approximately one-tenth of the timber ties are in poor condition, and these are found primarily on the Canadian side of the structure. The load ratings for this structure indicate that a 289,000-lb box car can traverse the bridge at approximately 25 mph. Since the capacity of this structure is slightly greater than the desired loading, a detailed structural evaluation of the existing load rating calculations should be conducted of all components including the substructures prior to increasing the acceptable load limits of this rail line. An evaluation of the train speed should be performed to determine if the trains could operate at a slower speed in order to reduce the dynamic loading associated with moving freight cars.

Figure 6-01 Sprague Falls International Bridge.

| MP | Structure | Length | Built | Recommendation | Est. Cost |
|---|---|---|---|---|---|
| 273.77 | Sprague Falls (International) | 250 ft | 1905 | <ul style="list-style-type: none"> <li>▪ Repair concrete scaling, spalling, and cracking at piers and abutments, and wingwalls.</li> <li>▪ Secure/install shims, plates, and anchor bolts.</li> <li>▪ Install steel plates (ice protection) along face of piers at waterline.</li> <li>▪ Replace 25 of 214 ties.</li> </ul> | \$500,000 <sup>1</sup> |

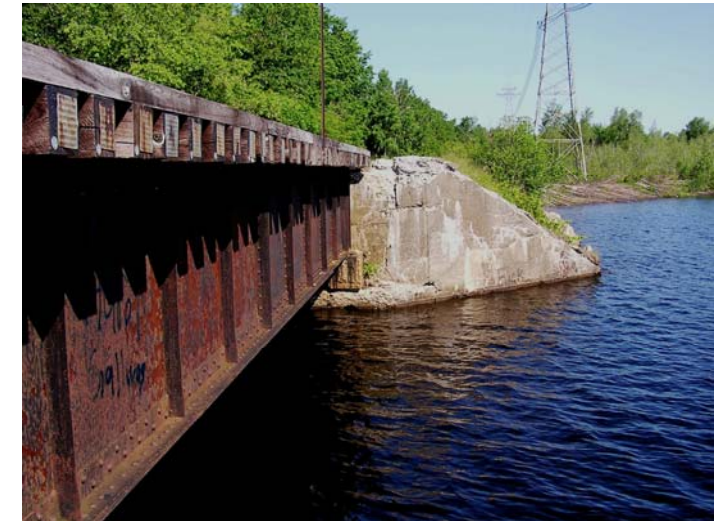
Figure 6-02 Sprague Falls International Bridge. Note severe deterioration to the abutment seat and wingwalls.

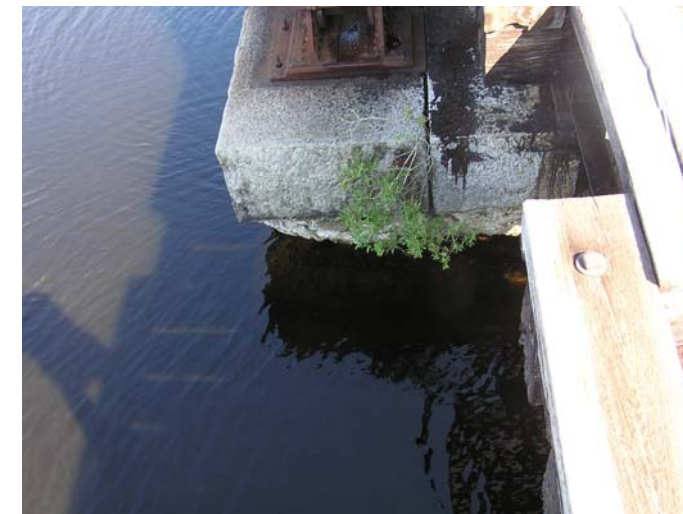
Figure 6-03 Sprague Falls International Bridge. Note severe scaling to the concrete pier immediately below granite block.

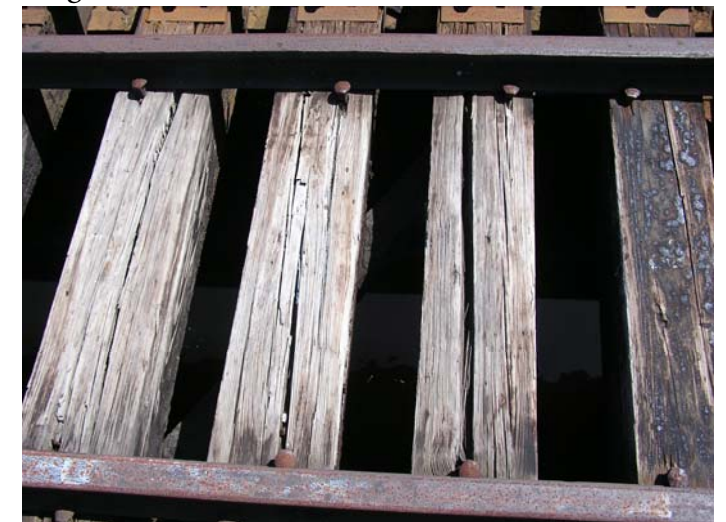
Figure 6-04 Sprague Falls International Bridge. Note typical deterioration to timber ties.

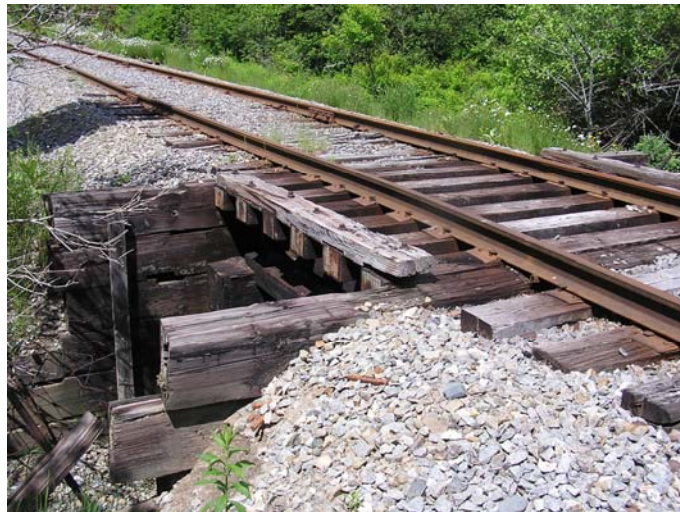
Built c. 1953, this 7-ft long single-span timber structure consists of two sets of two 8-in. x 16-in. timber girders supported by 12-in. x 12-in. pile caps and similarly sized timber posts. A half-buried pile cap supports the vertical posts along the ground line. There are six 6-in. x 8-in. timber ties along the structure. The timber elements are generally in fair condition, except for the components of the backwall which exhibit severe deterioration at their ends and decayed wood along their lengths. One timber girder exhibits crushing at its end. If no longer needed, this structure could be filled-in rather than replaced.

Figure 6-05 Cattle Pass, looking north.

| MP | Structure | Length | Built | Recommendation | Est. Cost |
|---|---|---|---|---|---|
| 268.93 | Cattle Pass (NB) | 7 ft | 1953 | <ul style="list-style-type: none"> <li>▪ Replace structure or fill-in. <sup>2,3</sup></li> </ul> | \$100,000 |

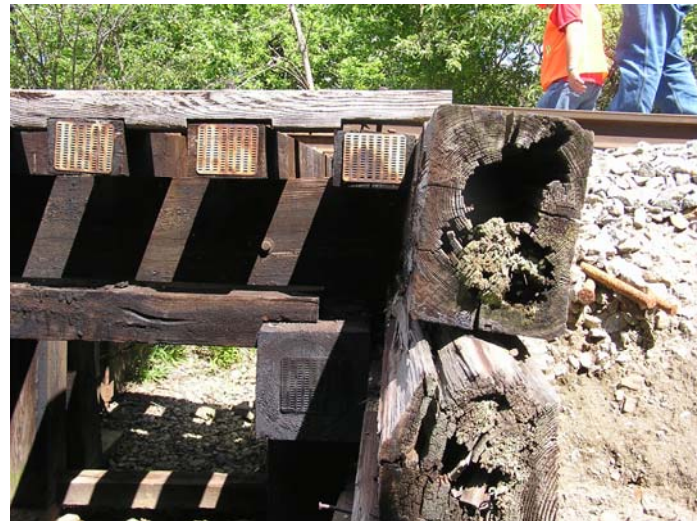
Figure 6-06 Cattle Pass. Note deterioration to timber backwall.

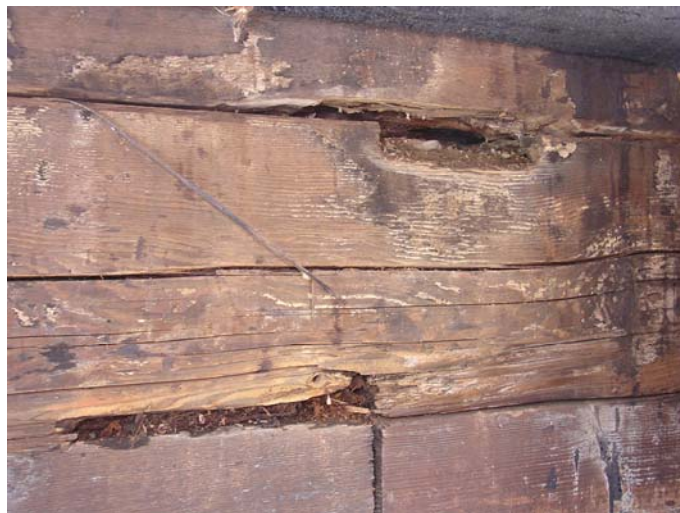
Figure 6-07 Cattle Pass. Note deterioration to timber backwall.

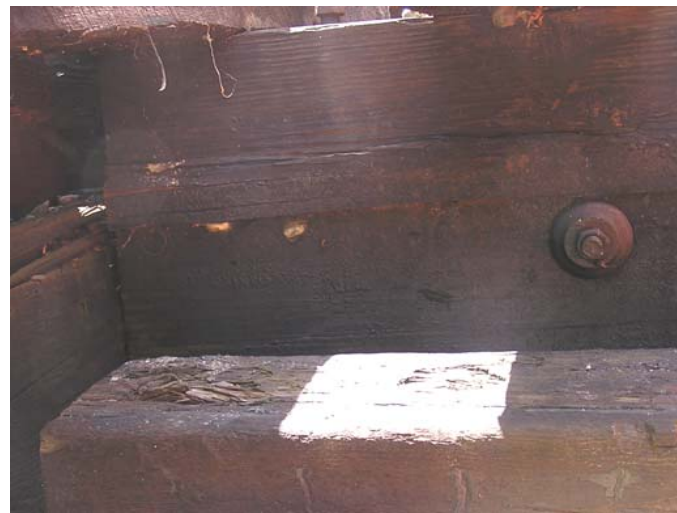
Figure 6-08 Cattle Pass. Note crushing/delamination of timber girder.

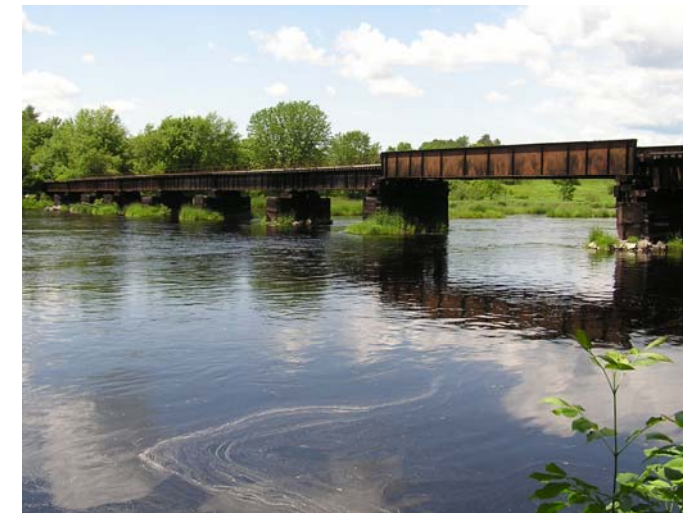
Built c. 1902, this nine-span steel structure over the St. Croix River consists of a 68-ft long main span through-girder and eight steel deck girder spans ranging in length from 35 ft to 49 ft. Stone-filled timber cribs form each of the eight piers while a concrete abutment supports the U.S. side along the river and a stone-filled timber crib supports the Canadian side. Ties have been replaced periodically since the mid-1990's, but most recently the replacements have been made using oak ties. Oak ties appear to split easily and several now need replacement. Overall, approximately twenty percent of all the ties should be replaced: 50 oak ties on the Canadian side, 12 oak ties on the U.S. side, and 13 vintage ties on the U.S. side. Select timber blocking elements exhibit severe crushing at Piers 1 and 2, where steel bearing plates are sinking into the timber. Organic decay in the timbers is prevalent throughout, which is a primary concern since most steel girders bear directly on timber blocking and cribbing elements, rather than the central portion of the piers. Some piers require additional stone fill material. The load ratings for this structure indicate that a 300,000-lb box car can traverse the bridge at approximately 25 mph. Since the capacity of this structure is slightly greater than the desired loading (286,000-lbs), a detailed structural evaluation of the existing load rating calculations should be conducted of all components including the substructures prior to increasing the acceptable load limits of this rail line. An evaluation of the train speed should be performed to determine if the trains could operate at a slower speed in order to reduce the dynamic loading associated with moving freight cars.

Figure 6-09 Baring International Bridge, looking south.

| MP | Structure | Length | Built | Recommendation | Est. Cost |
|---|---|---|---|---|---|
| 268.65 | Baring Bridge (International) | 453 ft | 1902/<br>1904 | <ul style="list-style-type: none"> <li>▪ Replace select timber blocking members at piers.</li> <li>▪ Fill/strengthen select timber cribs and piers with stone/concrete.</li> <li>▪ Extend steel girders to ensure adequate steel bearing atop piers.</li> <li>▪ Replace 75 of 374 ties.</li> </ul> | \$1,000,000 <sup>1</sup> |

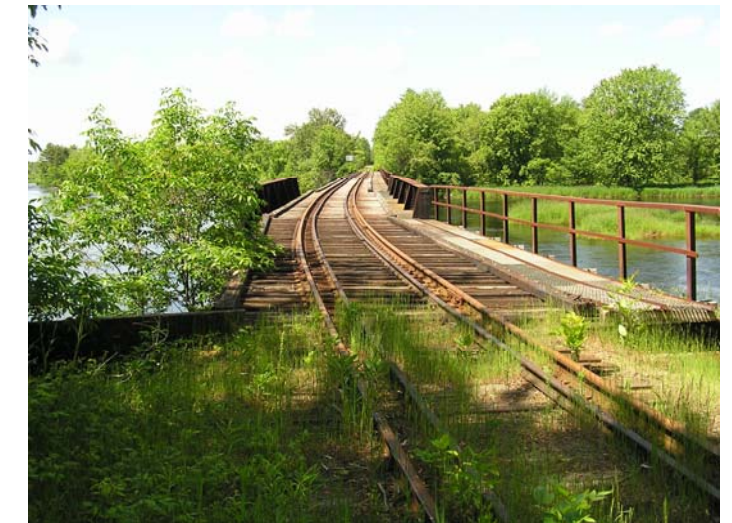
Figure 6-10 Baring International Bridge. Track view from U.S. approach.

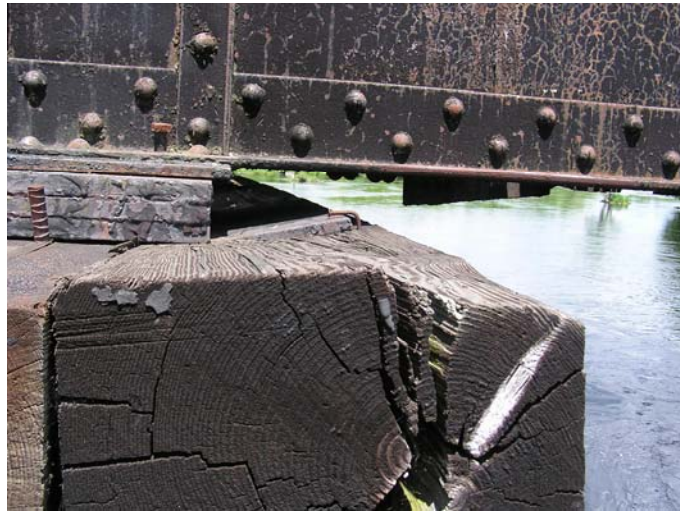
Figure 6-11 Baring International Bridge. Note rotated shims and new steel added to girder.

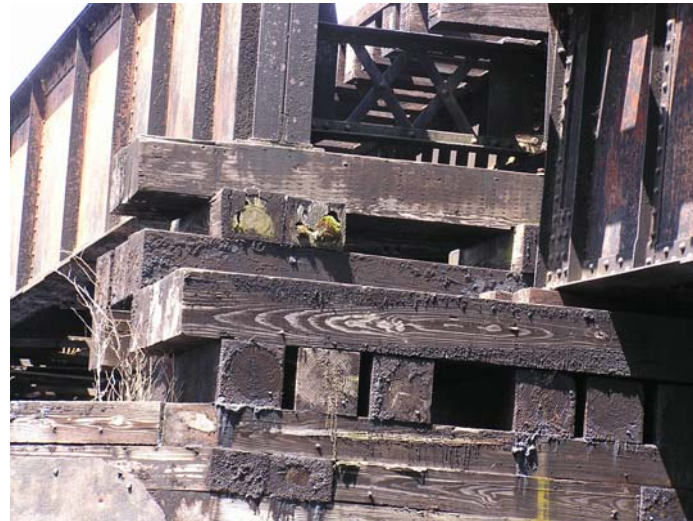
Figure 6-12 Baring International Bridge. Note crushing of timber post support, and deterioration in blocking.

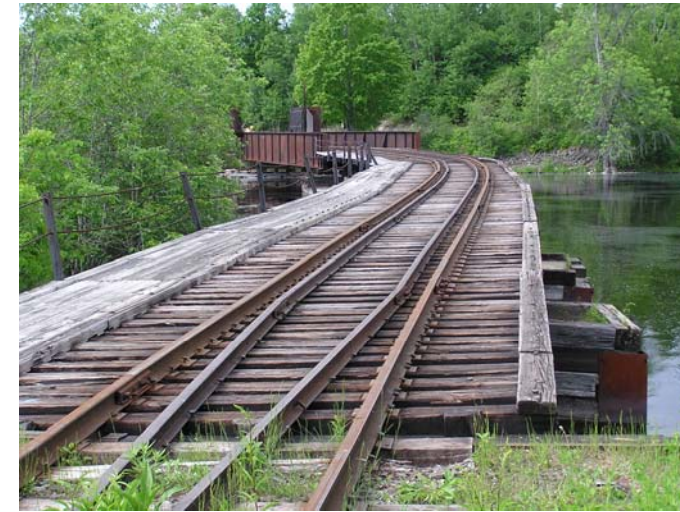
Figure 6-13 Salmon Falls International Bridge, looking south.

Built c. 1896, this six-span steel structure consists of a 85-ft long main span through girder followed by five steel deck girder spans ranging in length from 27 ft to 58 ft. Stone-filled timber cribs form each of the five piers while concrete abutments support the structures along each side of the river. A rehabilitation project in 1996 was undertaken to restore stability to the piers via grouting and solidifying the pier mass. Structural elements contain varying degrees of deterioration and distress which will require replacement such as timber blocking and concrete surfaces at the abutments. The bearing points of the steel girders are very close to the edge of the piers and in some cases the girders bear directly on the timber cribbing rather than the central concrete portion of the pier. For this reason, the stability of the piers is critical, yet remains uncertain at this time until an underwater inspection can be conducted. In either case, the steel girders should be modified to ensure that their ends bear directly on sound concrete. Approximately two-thirds (180 of 263) of the ties should be replaced. The load ratings for this structure indicate that a 282,000-lb box car can traverse the bridge at approximately 10 mph. Since the capacity of this structure is slightly less than the desired loading (286,000-lbs), a detailed structural evaluation of the existing load rating calculations should be conducted of all components including the substructures prior to increasing the acceptable load limits of this rail line. Trains should operate at the slowest speed possible in order to reduce the dynamic loading associated with moving freight cars. This structure should be replaced if traffic volumes are significantly increased as described in Chapter 2 FUTURE INFRASTRUCTURE IMPROVEMENTS.

| MP | Structure | Length | Built | Recommendation | Est. Cost |
|---|---|---|---|---|---|
| 269.02 | Salmon Falls (International) | 292 ft | 1896 | <ul style="list-style-type: none"> <li>▪ Assume major rehabilitation of up to two select piers in waterway.</li> <li>▪ Replace select timber blocking members at piers.</li> <li>▪ Extend lengths of steel girders.</li> <li>▪ Secure shims and anchorages.</li> <li>▪ Replace 180 of 263 ties.</li> </ul> | \$1,000,000 <sup>1</sup> |

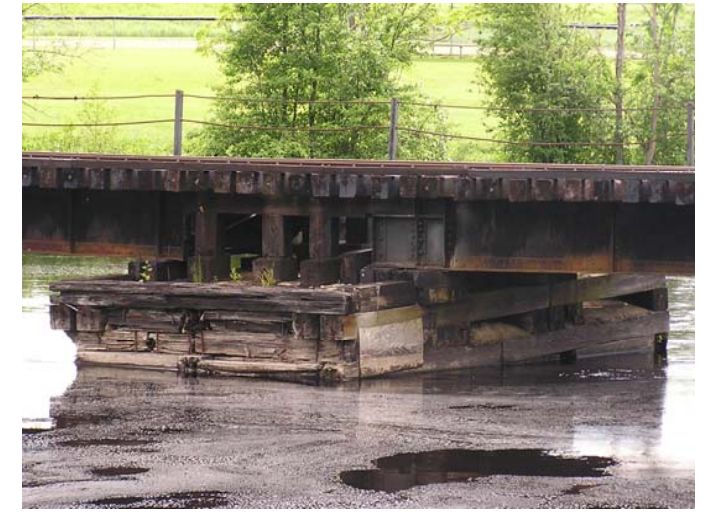
Figure 6-14 Salmon Falls International Bridge. Note uneven timber cribbing which supports the steel girders.

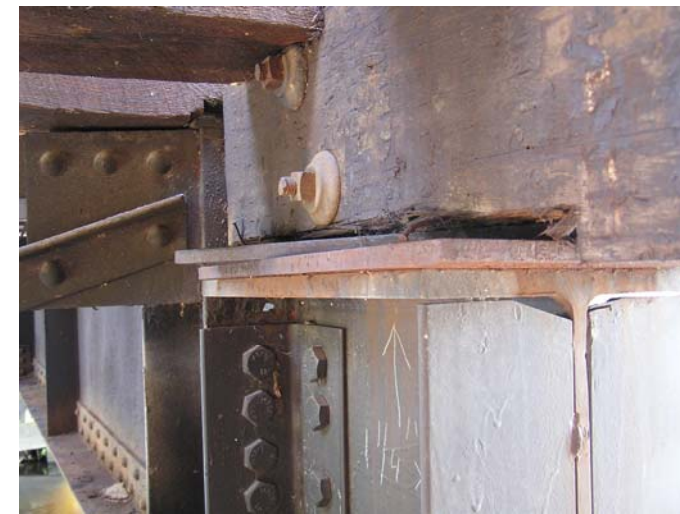
Figure 6-15 Salmon Falls International Bridge. Note rotated shims and new steel added to girder.

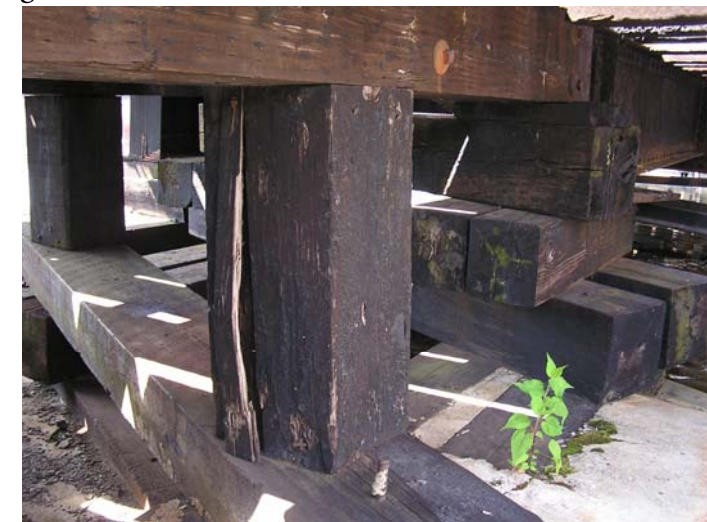
Figure 6-16 Salmon Falls International Bridge. Note crushing of timber post support, and decay in blocking.

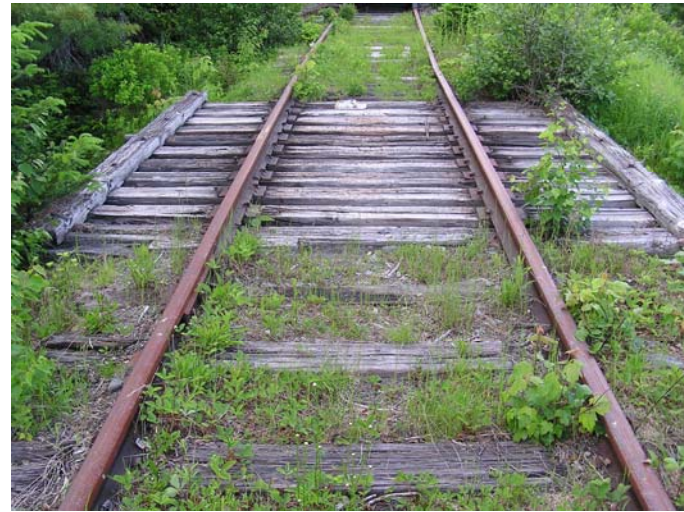
This 14-ft long single-span timber structure consists of two sets of three 8-in. x 16-in. timbers girders and granite block abutments. At the abutments, the girders are supported by horizontal timber members along the abutment seat which contain numerous timber shims to fill the voids between the timber and the granite blocks. This area typically contains vegetation growth and loose shims. Of the six timber girders, at least two exhibit decayed wood and will require replacement. It is likely that additional girders will require replacement once the railroad ties are removed and a more detailed inspection can be conducted. This structure could be replaced in its entirety. The eleven timber ties are 6-in. x 8-in. members which contain splits, organic decay, and general deterioration.

Figure 6-17 Bridge Over Moosehorn Brook, looking north.

| MP | Structure | Length | Built | Recommendation | Est. Cost |
|---|---|---|---|--|---|
| 258.75 | Moosehorn Brook | 14 ft | Unk. | ▪ Replace structure. <sup>2</sup> | \$250,000 |

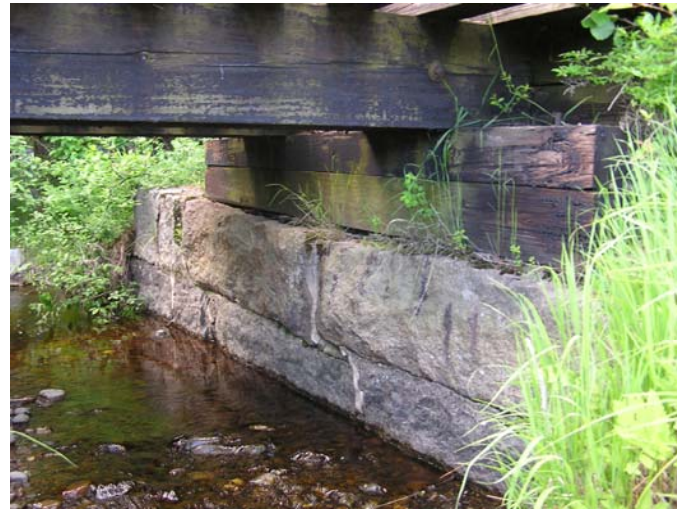
Figure 6-18 Bridge Over Moosehorn Brook. Note loose shims and vegetation growth at abutment seat.

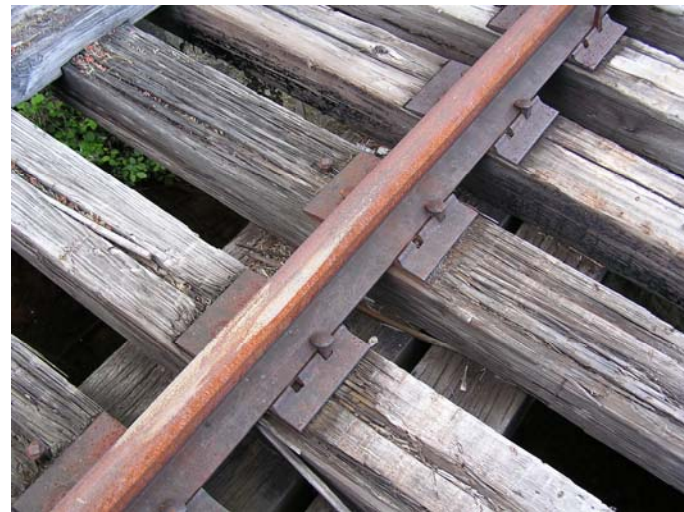
Figure 6-19 Bridge Over Moosehorn Brook. Note poor condition of the timber ties.

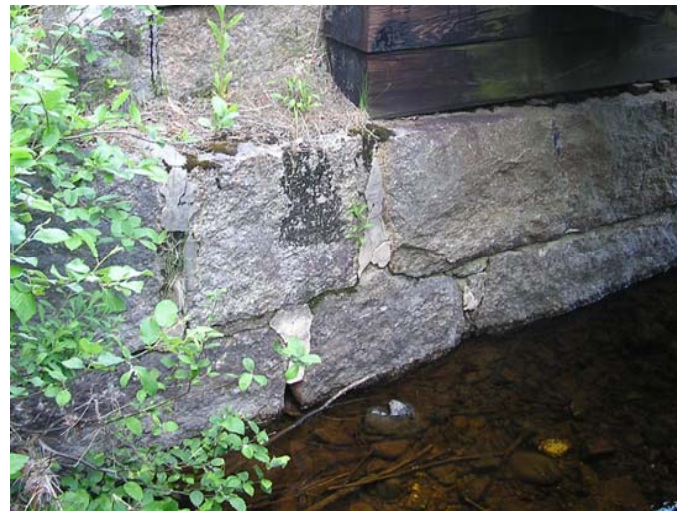
Figure 6-20 Bridge Over Moosehorn Brook, granite block abutments with pointing.

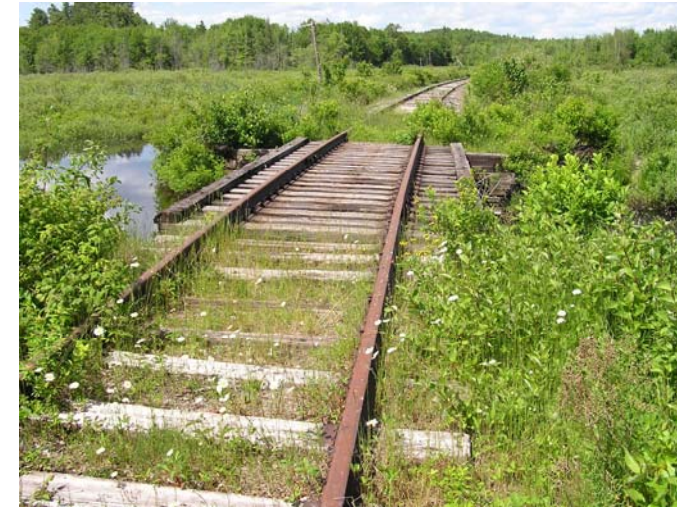
Built c. 1965, this 27-ft long bridge consists of a single-span deck girder. A beaver dam along the west side of the structure is currently pushing against the exterior girder and blocking water flow beneath the bridge. Any further build-up of the dam could create a significant lateral loading across the bridge. The timber abutment seats contain splits and organic decay, and the timber backwall contains general deterioration and areas of decayed wood. The timber ties are generally in fair condition with excessive wear from snowmobile treads and isolated areas of decayed wood. Behind each abutment backwall is evidence of subsidence approximately 6 inches deep.

Figure 6-21 Bridge Over Round Pond Stream, looking north.

| MP | Structure | Length | Built | Recommendation | Est. Cost |
|---|---|---|---|--|---|
| 256.57 | Round Pond Stream | 27 ft | 1965 | ▪ Replace timber backwalls and abutment seats with concrete abutment.<br>▪ Remove beaver dam.<br>▪ Replace all 22 ties.<br>▪ Provide fill/ballast behind abutment. | \$150,000 <sup>4</sup> |

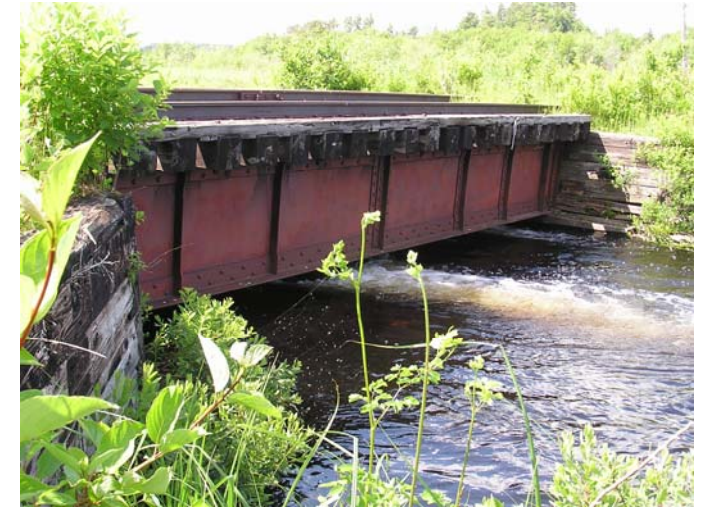
Figure 6-22 Bridge Over Round Pond Stream. Note high water flow due to beaver dam on opposite side.

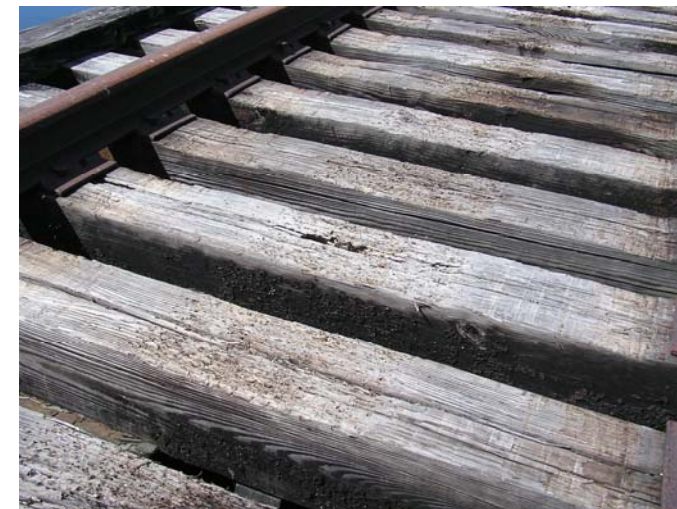
Figure 6-23 Bridge Over Round Pond Stream, timber ties.

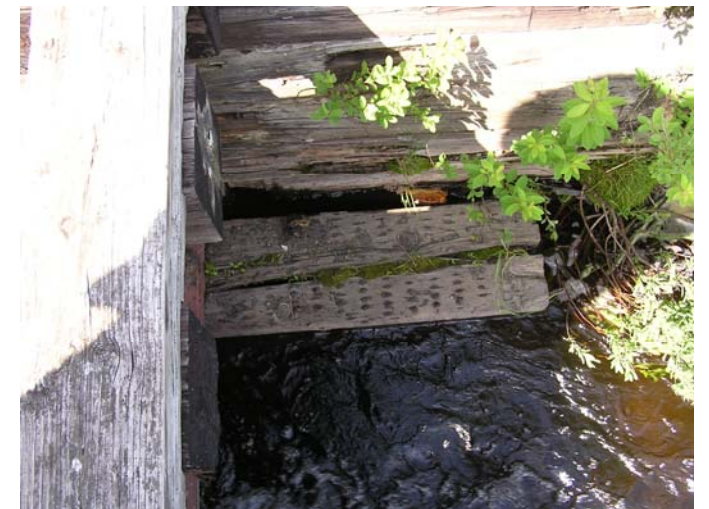
Figure 6-24 Bridge Over Round Pond Stream, top of timber abutment seat with split.

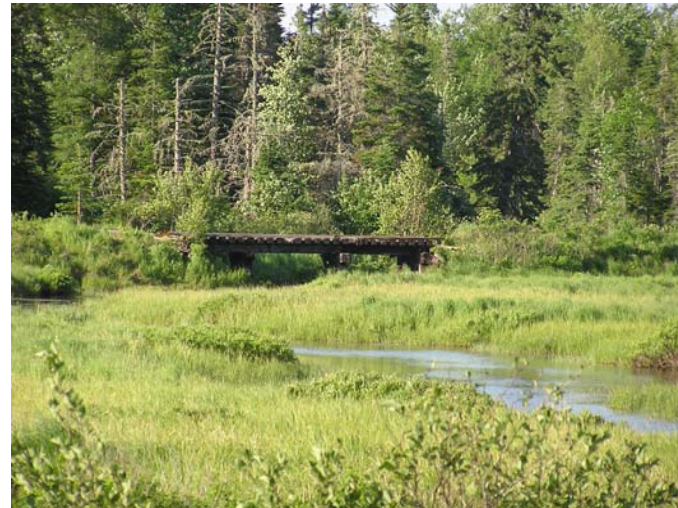
This 31-ft long three-span timber trestle consists of two timber pile bents spaced approximately 12 ft on center with six 14-in. diameter timber piles per bent. Each pile cap supports two sets of three 8-in. x 16-in. girders. There appear to be two levels of pile caps at each bent, but it was not possible to verify the construction method due to the debris around each bent. The condition of the timber is generally poor as the pile caps and tops of the timber piles exhibit splits and non-bearing conditions, respectively. One timber batter pile contains major deterioration and is non-bearing, while three of the six piles at the eastern timber backwall exhibit reduced bearing. The 28 timber ties are typically 8-in. x 8-in. members exhibiting splits, crushing, and general deterioration. While individual timber components could be replaced to restore structural capacity, this structure should be replaced in its entirety.

Figure 6-25 Bridge Over Ohio Brook, looking north.

| MP | Structure | Length | Built | Recommendation | Est. Cost |
|---|---|---|---|---|---|
| 254.74 | Bridge Over Ohio Brook | 31 ft | Unk. | ▪ Replace structure. <sup>5</sup> | \$500,000 |

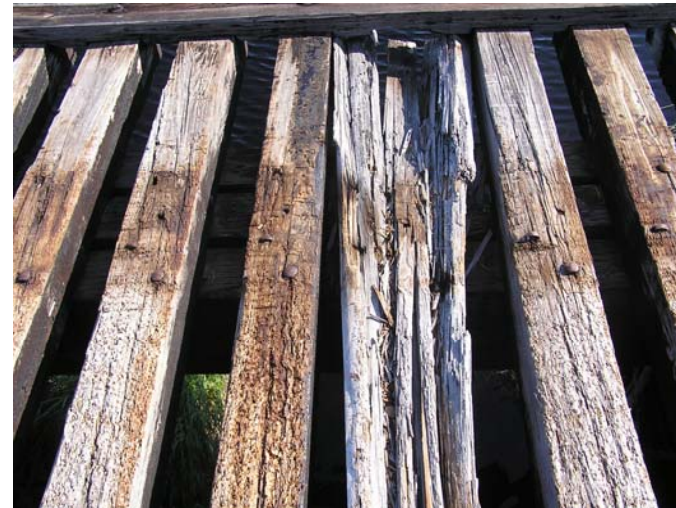
Figure 6-26 Bridge Over Ohio Brook, timber ties with severe deterioration.

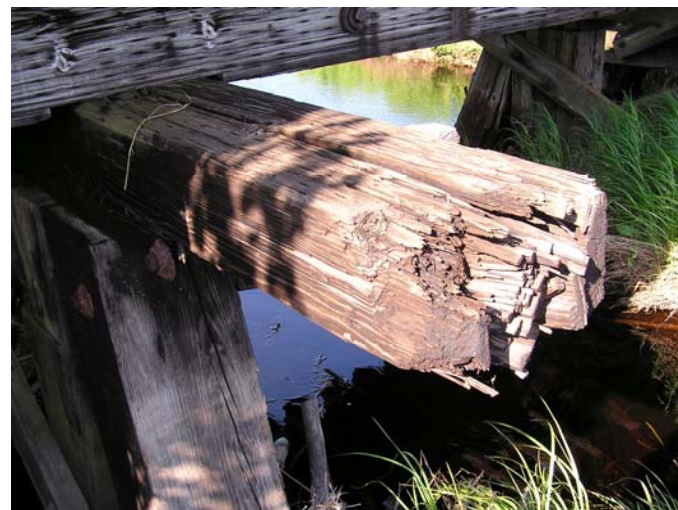
Figure 6-27 Bridge Over Ohio Brook. Note severe deterioration at end of pile cap which continues throughout the length of the member.

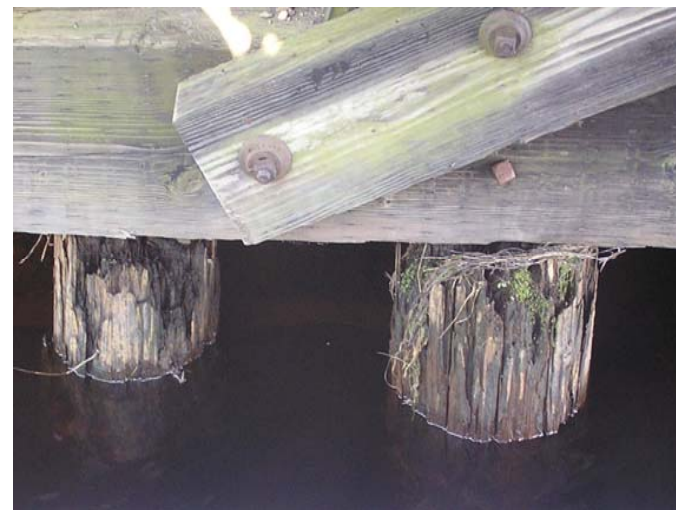
Figure 6-28 Bridge Over Ohio Brook. Note the deterioration at the top of the piles which result in reduced/non-bearing conditions.

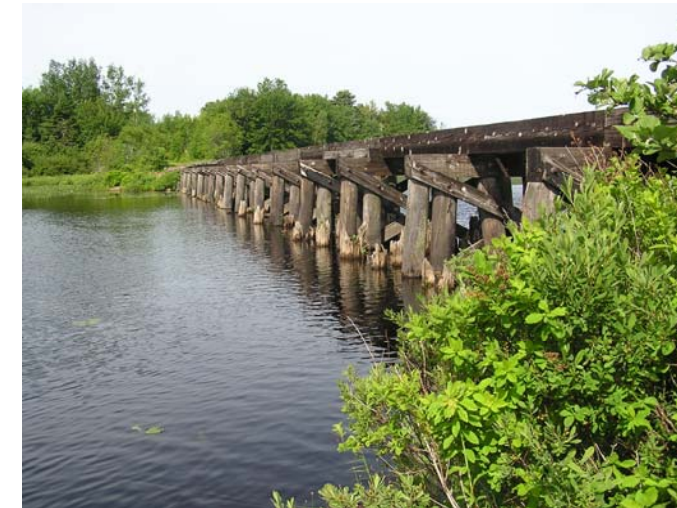
This 200-ft timber trestle consists of timber pile bents spaced approximately 12 ft on center with six 14-in. diameter timber piles per bent, and at one time contained a timber girder superstructure. The condition of the timber varies from fair to poor as some pile caps exhibit splits and organic decay to various degrees of deterioration. All deck elements have been removed from this structure and are no longer present save a few timber deck boards that now serve pedestrians and snowmobiles. Timber backwalls are in poor condition and the lack of abutments results in significant subsidence and loss of fill leading up to the structure at both ends. One pile bent is missing near the western side of the bridge, and the interior 8-in. x 16-in. girders have been laid flat. The condition of these girders is fair at best, while most if not all of the girders and pile caps will require replacement. A detailed structural evaluation of the timber pile bents is needed to determine whether this structure should be replaced in its entirety.

Figure 6-29 Bridge Over Pennamaquan River, looking west.

| MP | Structure | Length | Built | Recommendation | Est. Cost |
|---|---|---|---|---|---|
| 257.84 | Bridge Over Pennamaquan River | 200 ft | Unk. | ▪ Replace structure. <sup>5</sup> | \$3,000,000 |

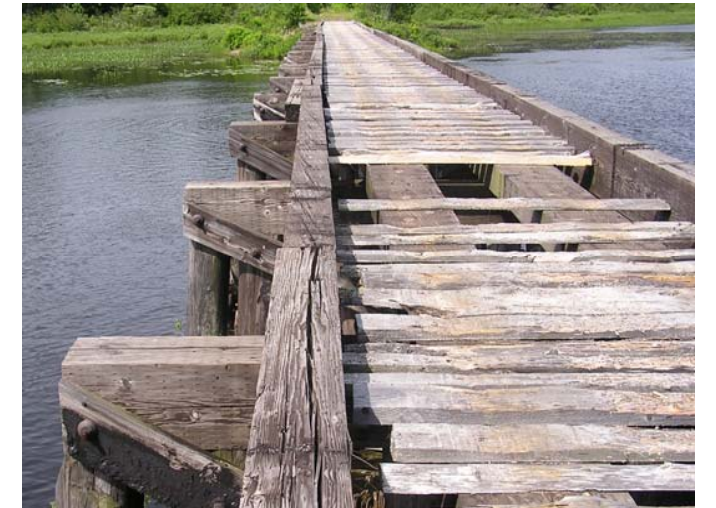
Figure 6-30 Bridge Over Pennamaquan River, top of deck. Note interior girders turned on their sides.

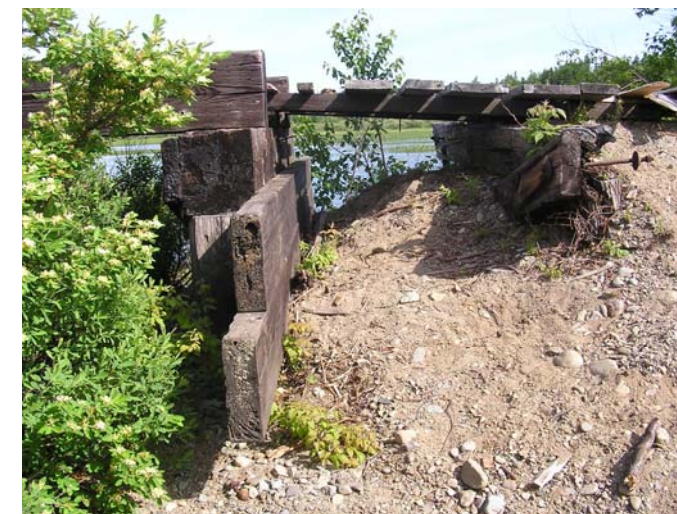
Figure 6-31 Bridge Over Pennamaquan River, depleted ballast and fill at backwall.

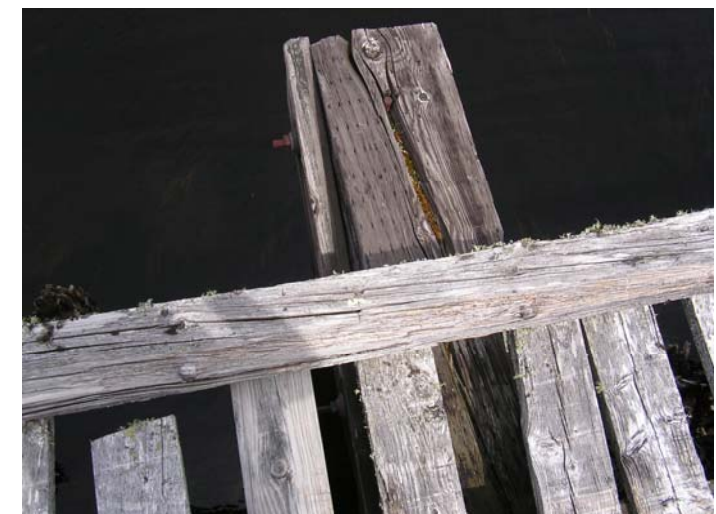
Figure 6-32 Bridge Over Pennamaquan River, typical condition of pile cap with deterioration.

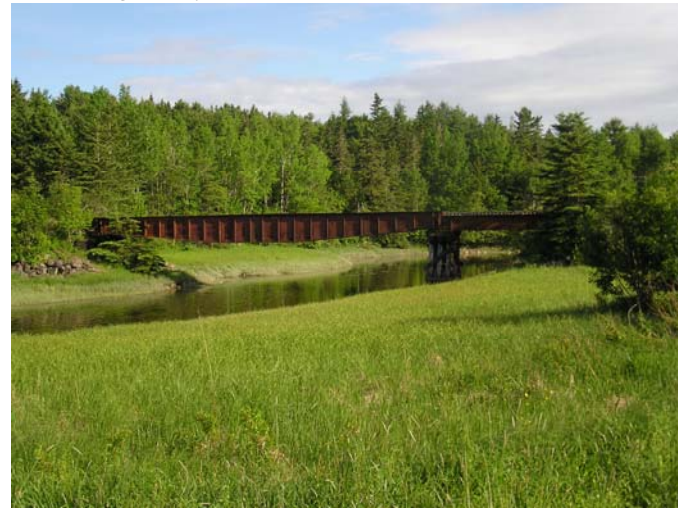
Built c. 1916, this 110-ft long bridge consists of a two-span steel deck girder structure supported by a three-pile bent timber substructure pier along the river edge. The main span, which at one time functioned as a swing bridge at a different location, is approximately 80 ft long while the secondary span is approximately 30 ft long. All deck elements have been removed from this structure and are no longer present save a few timber deck boards that may have served pedestrians and snowmobiles at one time. Timber backwalls at the abutments exhibit organic decay. Ballast and fill material behind the backwalls is depleted both behind and to the sides of the abutments. Based on the timber stub piles present between the existing timber substructure and the west abutment, and the discoloration of the steel girders on the bottom side of the bottom flange, it is possible that an additional timber pile bents were once present. It should be noted that this bridge may not be required based on the location of the trans-load facility.

Figure 6-33 Bridge Over Little River looking south.

| MP | Structure | Length | Built | Recommendation | Est. Cost |
|---|---|---|---|---|---|
| 262.90 | Bridge Over Little River | 110 ft | 1916 | ▪ Replace structure. <sup>5</sup> | \$1,500,000 |

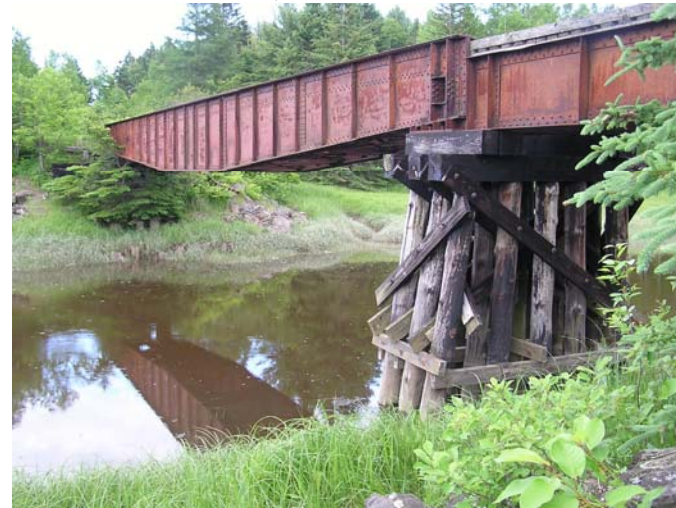
Figure 6-34 Bridge Over Little River, main span and timber pier support.

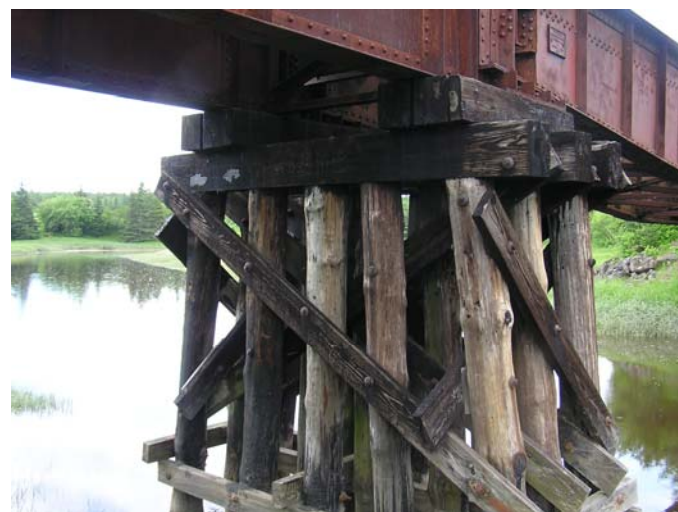
Figure 6-35 Bridge Over Little River, intermediate timber pier support.

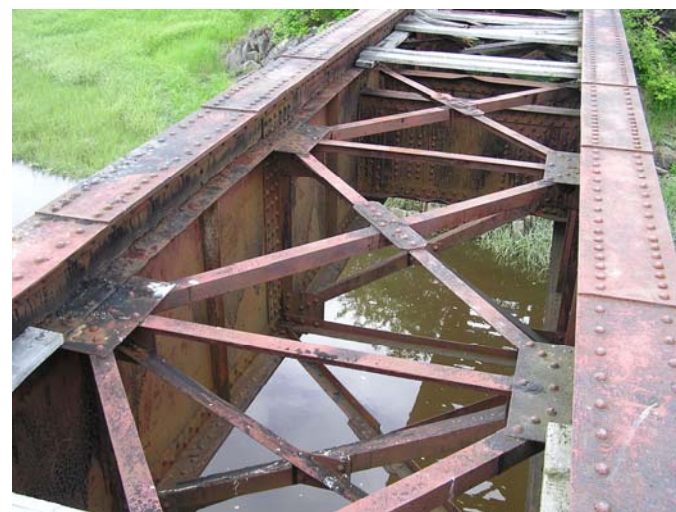
Figure 6-36 Bridge Over Little River, top of deck.
