**I – OVERVIEW**

**II. – PAN AM RAILWAY OWNED SEGMENT IN MAINE**

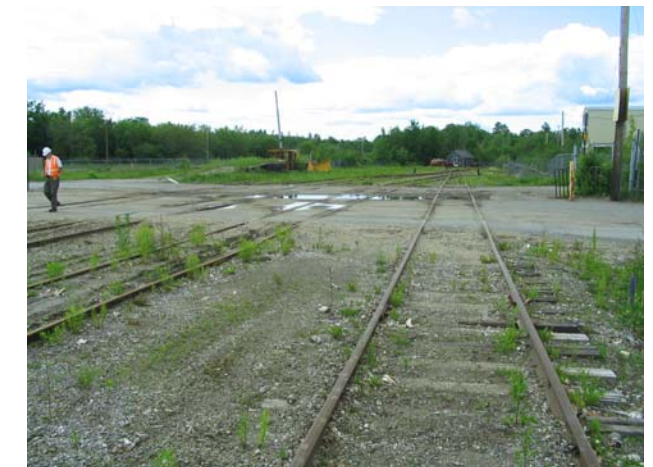
Figure 5-3 Woodland Yard, East End

1. An average of 15% of switch timber in the seven No.8 turnouts should be replaced. This would amount to 520 LF total of replacement timber.
2. Derailment damage should be repaired on Track 7. Approximately 230 feet of rail is rolled out on curve. Track should be re-gauged and replace 25% of crossties.
3. Correct track gage (4' - 10 1/4") in median between lanes, crossing to mill chip unloading, Track No. 7.
4. Replace approx. 20% of crossties (855 replacement crossties)
5. Install rail anchors on all tracks (3,375 total)

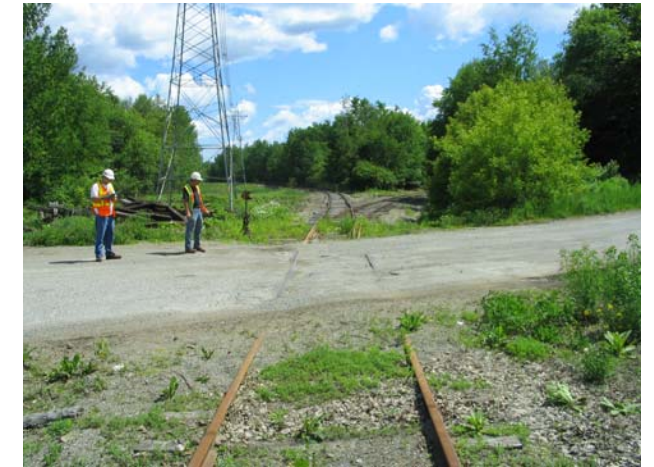
There are two grade crossings on this track segment. One has a very flat skew or crossing angle (Figure 5-4). It is assumed that new crossings surfaces and track would be constructed through these crossings.

Figure 5-5 Private Crossing near Woodland Jct. Note turnout that is north end of Wye

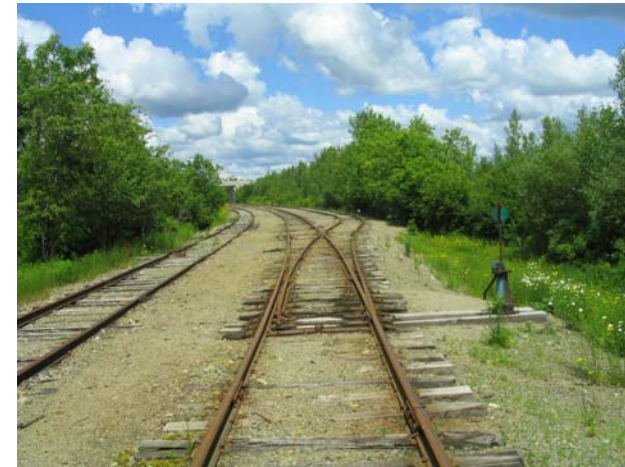
At Campbells Yard, (consisting of two parallel, double ended sidings on each side of the main track) the turnouts at the north end are both 85# No. 8 and would need at total of 692 LF of switch timber replacement. The turnout to Track No. 4 needs to have three missing frog bolts replaced. The south turnouts at Campbells yard, both 85#, No. 8, will need at total of 450 LF of switch timber replaced. The headblock timbers on the derail at the south end of track No. 4 need to be replaced, adding 30 LF of switch timber. Tracks 3 and 4 at Campbells Yard would require replacement of 775 crossties to be serviceable. Both tracks are constructed of 85# rail.

Figure 5-8 Campbells Sidings, South End

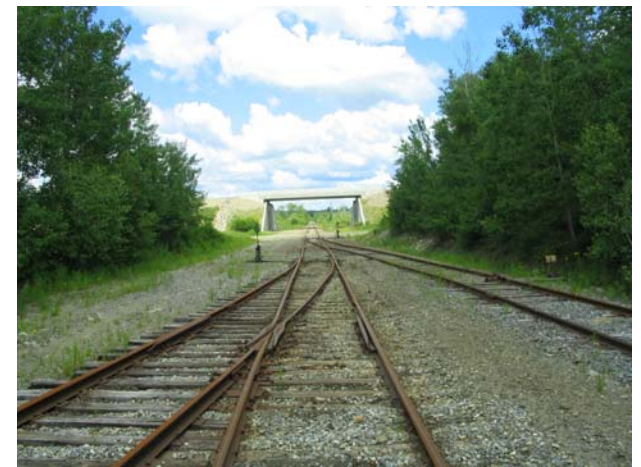
Figure 5-9 Campbells Sidings, North End

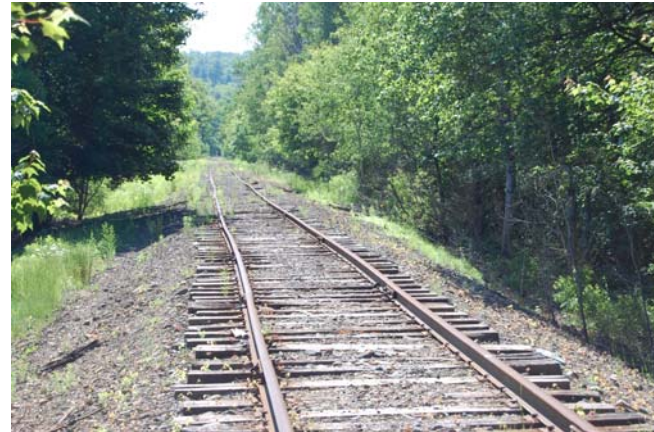
The 4.3 track miles of 75# rail should be replaced out-of-face. This rail exhibits numerous service failures such as broken bases, vertical split head defects and head and web separations.

Figure 5-13 Typical Track Conditions in Canadian Segment

Crosstie renewal rates on this segment vary from 20% to 40%. A total of 5,150 crossties should be renewed for an operation as FRA Class I condition. An additional 1,000 crossties should be renewed for a Class II condition.

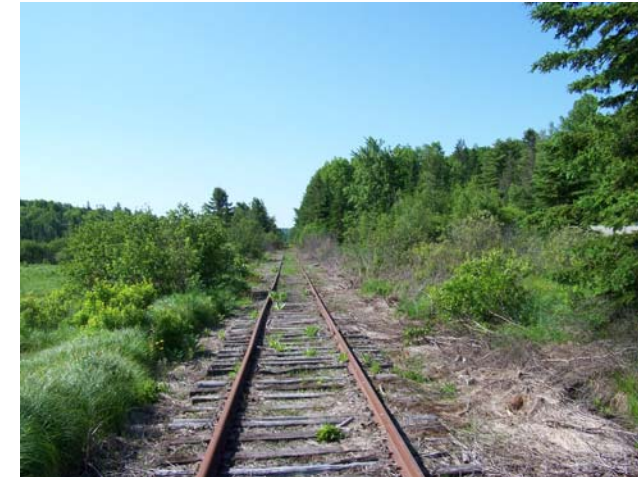
Figure 5-14 Typical Tangent Section

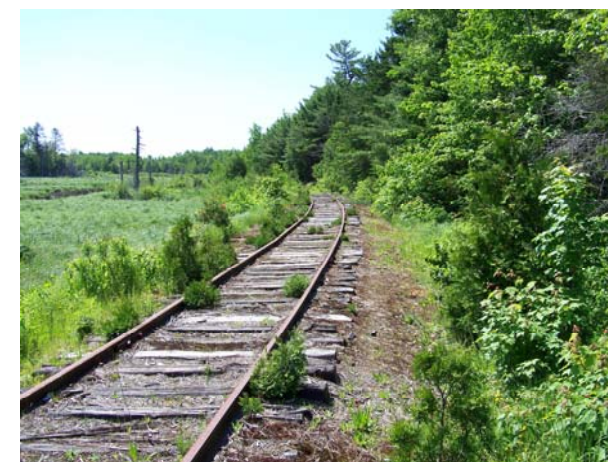
This segment is constructed of 85# ASCE rail, generally in serviceable condition. The rail joints are primarily head free toeless with some Weber joints randomly mixed in. Both types appear to be serviceable. There are few rail anchors in track and those in place should be reapplied to bear against crossties.

Figure 5-16 Track on Curve with Adjacent

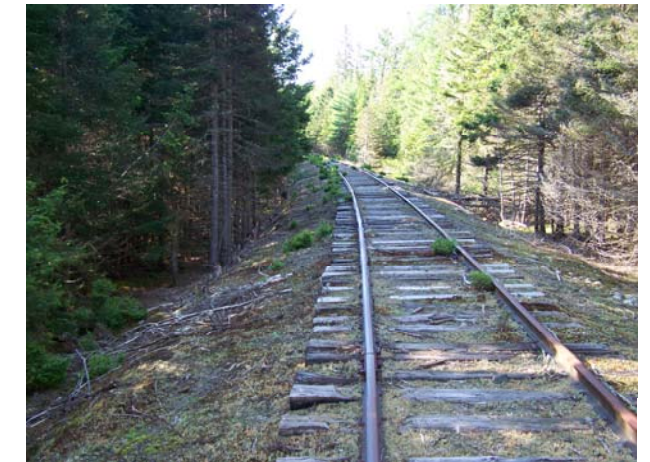
Figure 5-17 Track on Fill Section Wetland

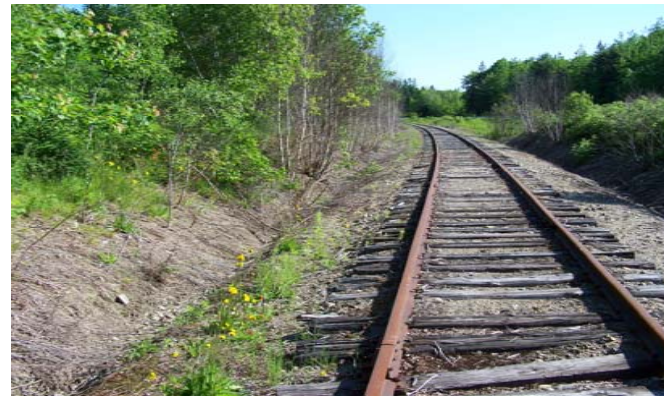
Figure 5-18 Representative Ditch Section

Considerable ditch cleaning is recommended. This cleaning will not require excavating large volumes of material, but should clean and reshape the inverts of existing ditches.

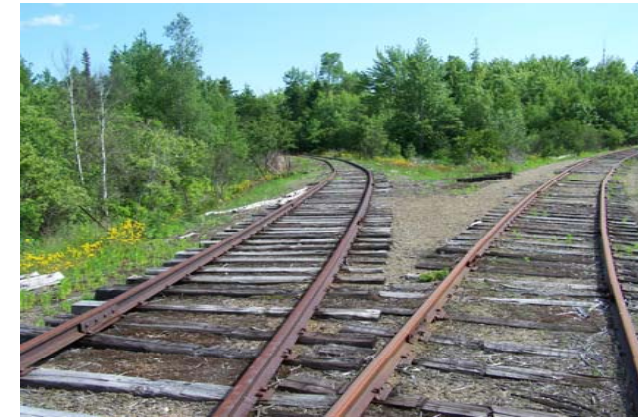
Figure 5-21 Ayers Jct. East Main Switch Behind Camera

The east main track switch at Ayers Junction (Figure 5-20) should be removed, along with the remaining main track west of the switch. The No. 8 - 85# turnout could be salvaged for reuse elsewhere. The salvaged Rail could be used elsewhere on the Project.

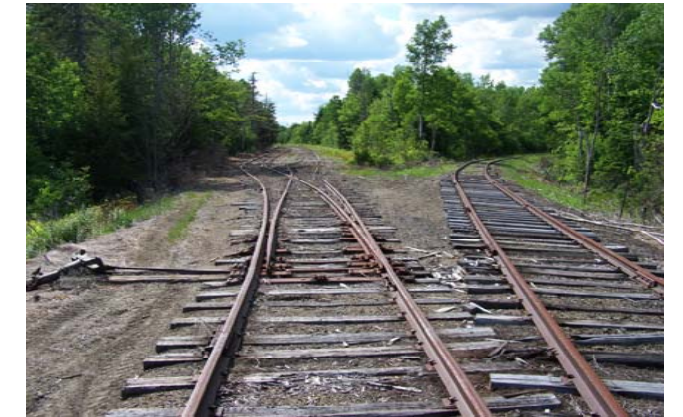
Figure 5-22 Tracks 5 & 7 Ayers Jct.

The tail track switch at the Ayers Junction wye should remain in place and be rehabilitated. This track, designated Track 7, should remain in place for about 300 feet for bad order car set outs and M.O.W. machines. The Track 5 turnouts, both 85# No. 8, should be removed, along with the body of the track, shown as 830 feet. The Track 7 turnout should have 100% timber replacement, or 692 LF.

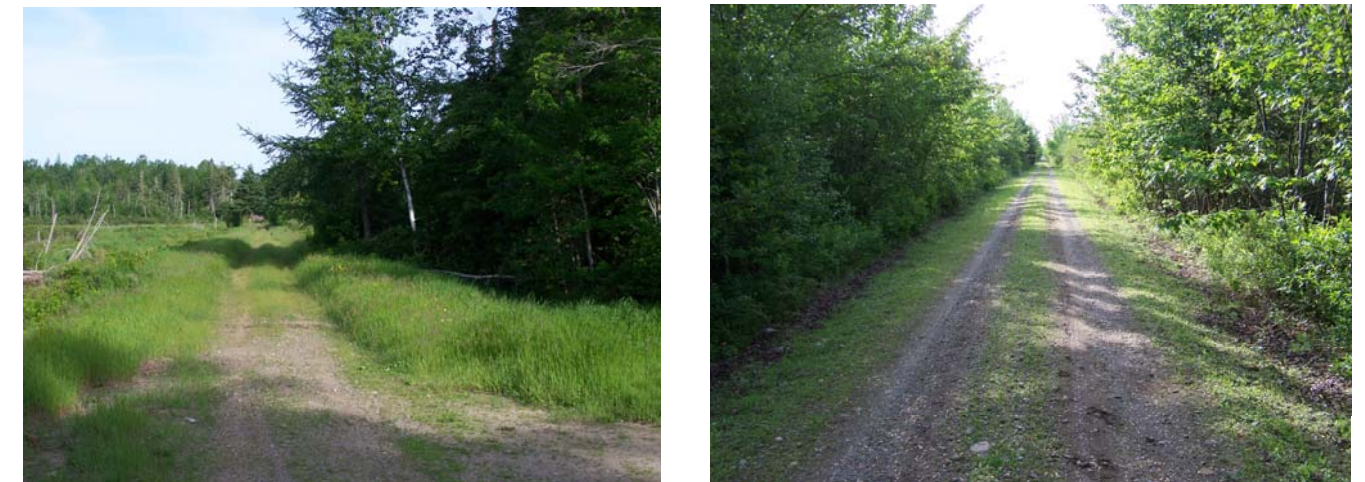
From this point south to Robbinston Road, MP 255.95, the gravel roadbed has been improved and kept graded. A homemade York- type rake was noted on a roadway which enters the right-of-way at about MP 254.75. The roadbed is being used by vehicles frequently.

Figures 5-29 and 5-30 Views of ROW east of Ayers Junction

Brush cutting and ditch cleaning should be performed virtually out-of-face from Ayers Jct. to Robbinston Road. There is heavy beaver activity in this segment and water had backed up to the point of saturating the roadbed in places.

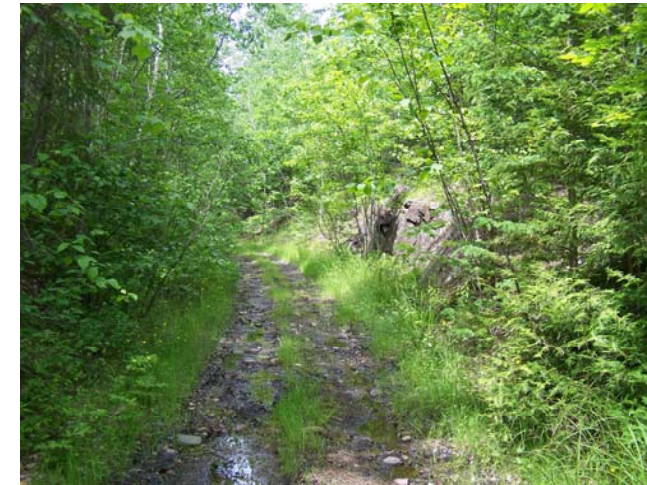
Figure 5-33 Wet Area in Rock Cut
